Technology Base for the ACR: FUEL CHANNELS

By Doug Rodgers, Director, Fuel Channels

**Presented to US Nuclear Regulatory Commission
Office of Nuclear Reactor Regulation**

September 26, 2002

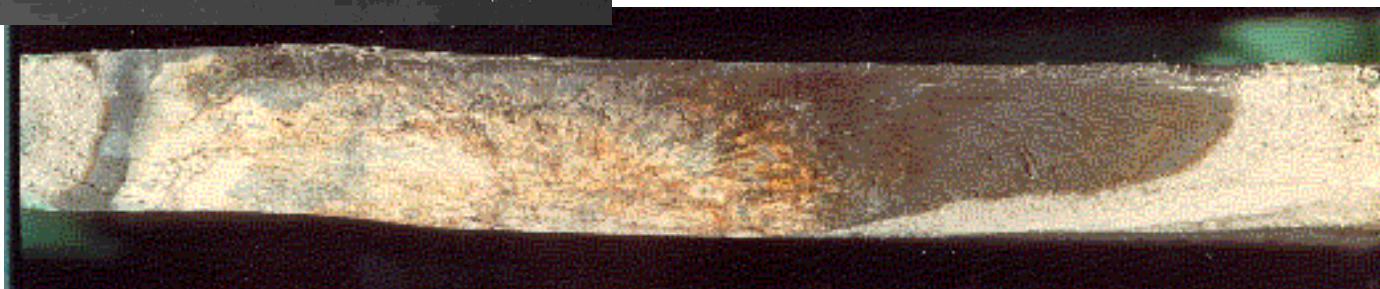
IN-REACTOR EXPERIENCE

- High residual stresses from over-rolling
- Delayed Hydride Cracking during reactor shutdowns only
- Leakage and detection
- Safe shutdown
- Replacement of pressure tubes

- Replace cracked pressure tubes
- Stress relieve other reactors with over-rolled pressure tube joints
- Development of zero-clearance rolled joint with lower residual stresses
- Implemented in subsequent reactor constructions, e.g. all CANDU 6 reactors

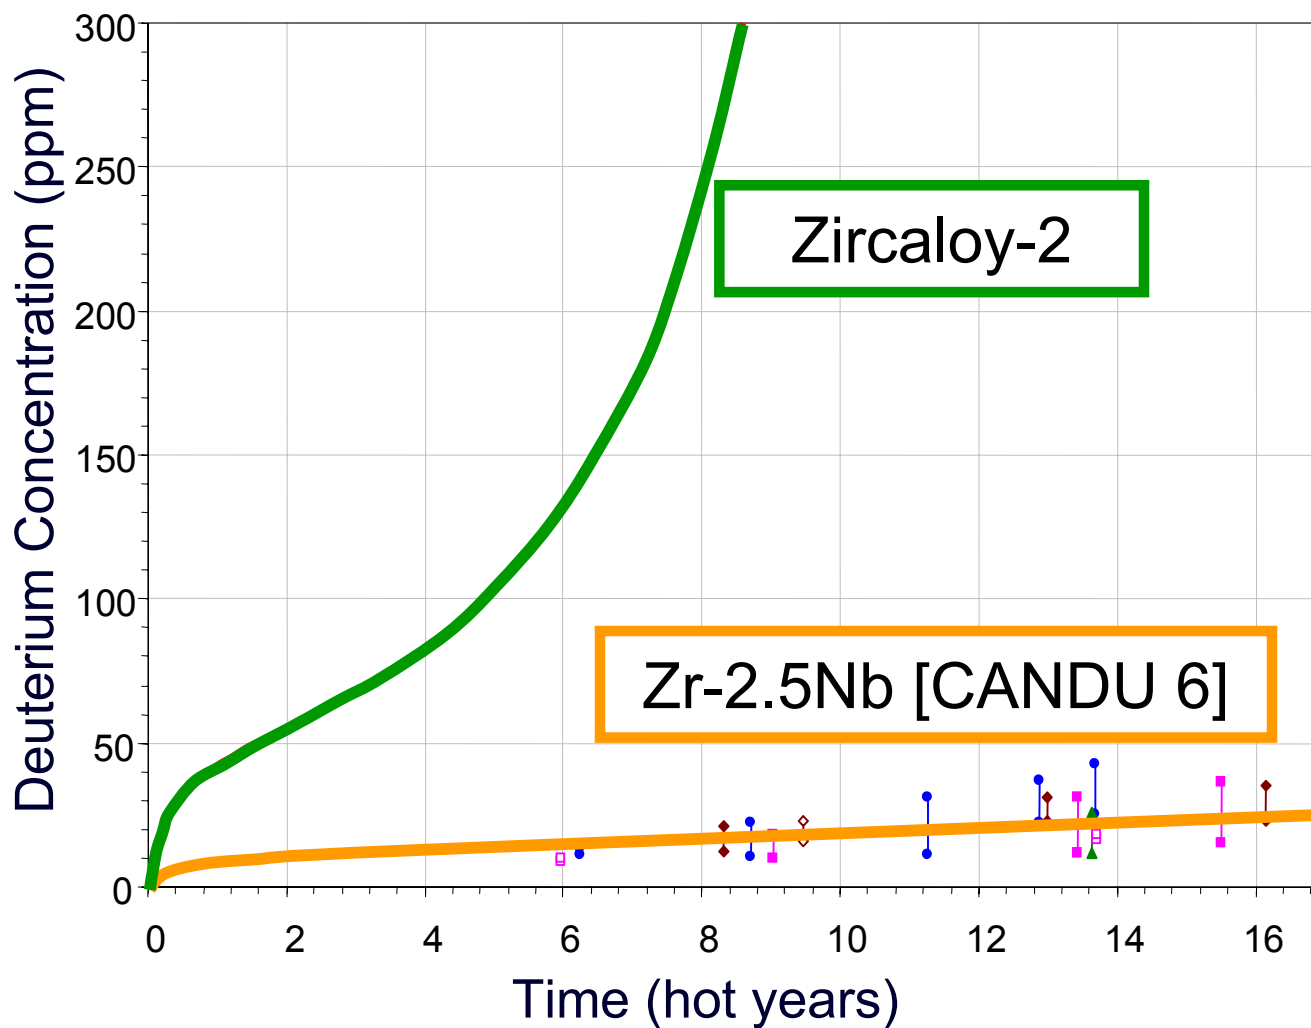
CORROSION & HYDROGEN INGRESS

- Interaction of hot coolant with zirconium
- Limited corrosion and hydrogen ingress
- Solubility limit for hydrogen in zirconium
- When the solubility limit is exceeded, there is the possibility of Delayed Hydride Cracking and changes in material properties

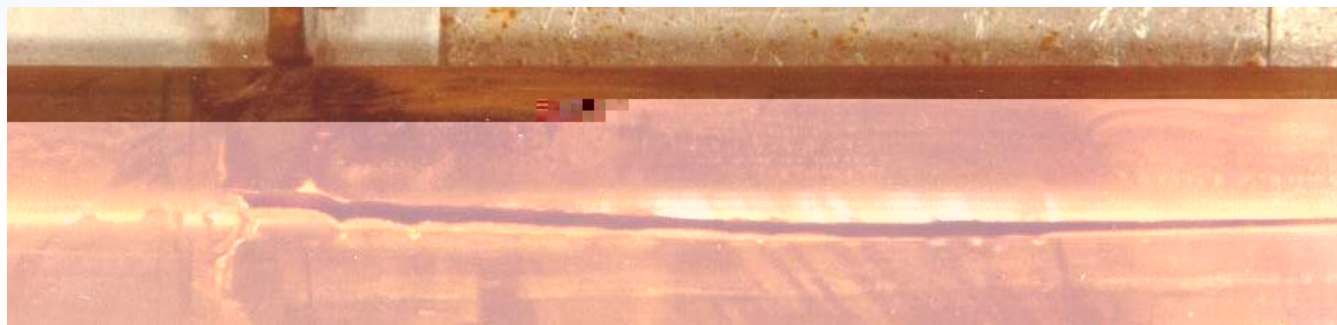
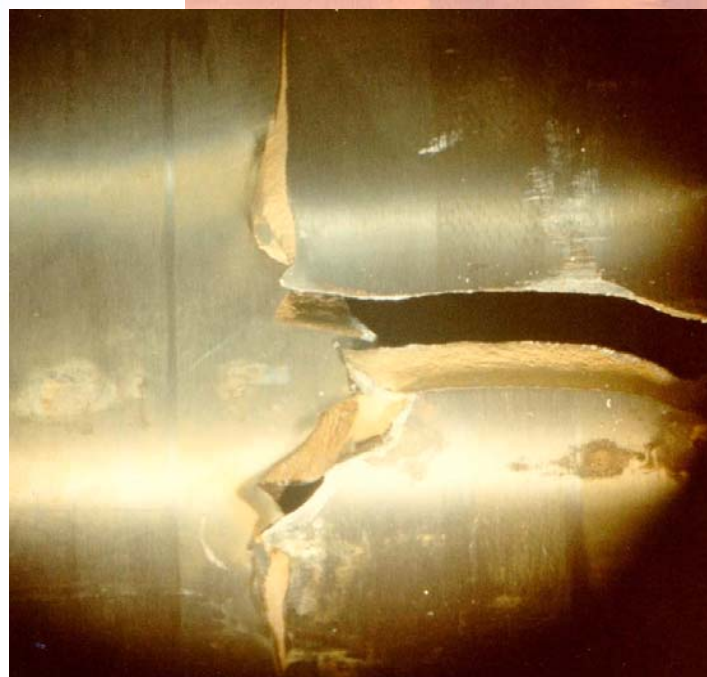
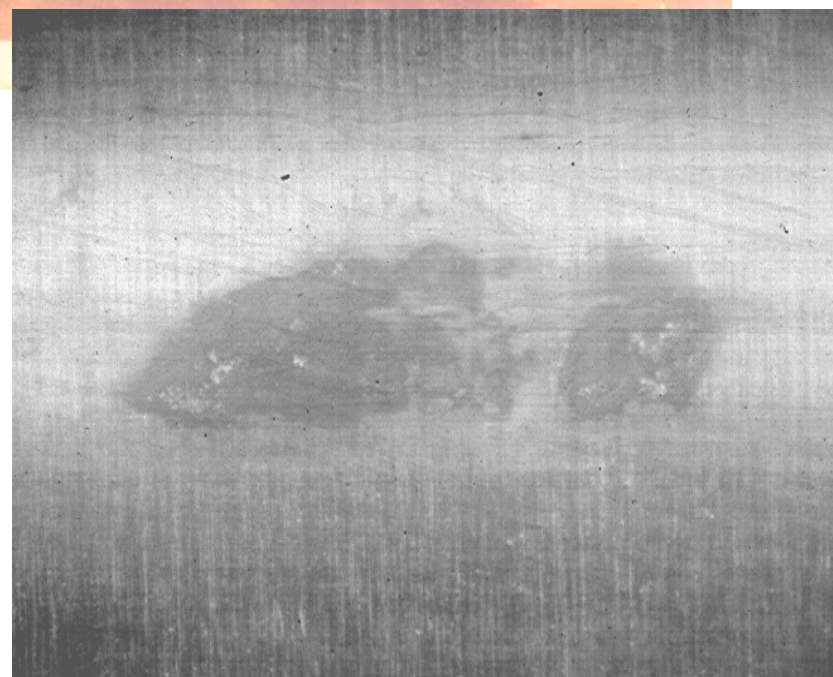
BLISTERS

- Spacer movement (2 spacers)
- High deuterium pick-up in Zircaloy-2
- Pressure tube sagged into contact with the calandria tube creating local “cold” spots
- Hydrogen diffusion and hydride blister formation
- Cracking of several brittle blisters
- Rupture of the pressure tube
- Shutdown and replacement of the pressure tube

- Re-tube Zircaloy-2 reactors with Zr-2.5Nb

- In-reactor inspections for spacer locations and hydride blisters
- Reposition spacers in operating reactors
- Assessment methodologies
- Install 4 tight-fitting spacers in new reactors

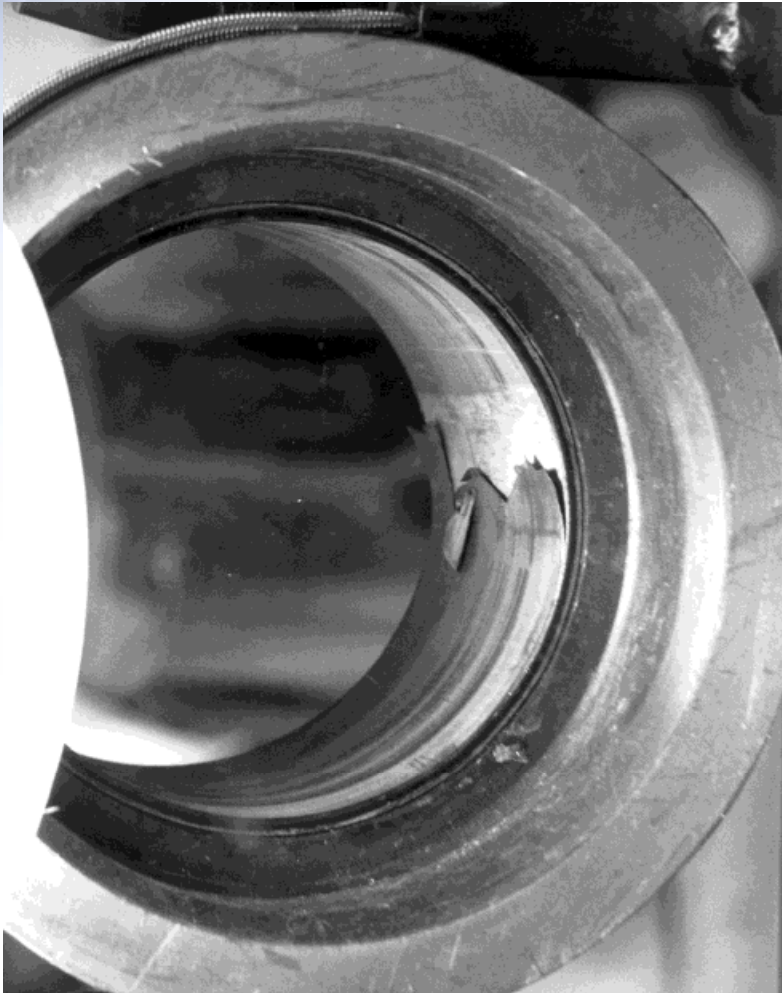
MANUFACTURING FLAW

- Residual stresses from over-rolling
- Manufacturing Flaw
- Delayed Hydride Cracking with multiple initiation sites
- Leakage and detection
- Safe shutdown

- Replace cracked pressure tube and ruptured calandria tube
- Inspect archive material for similar manufacturing flaws
- Inspect selected tubes in operating reactors
- Adjusted manufacturing process for all subsequent reactor constructions

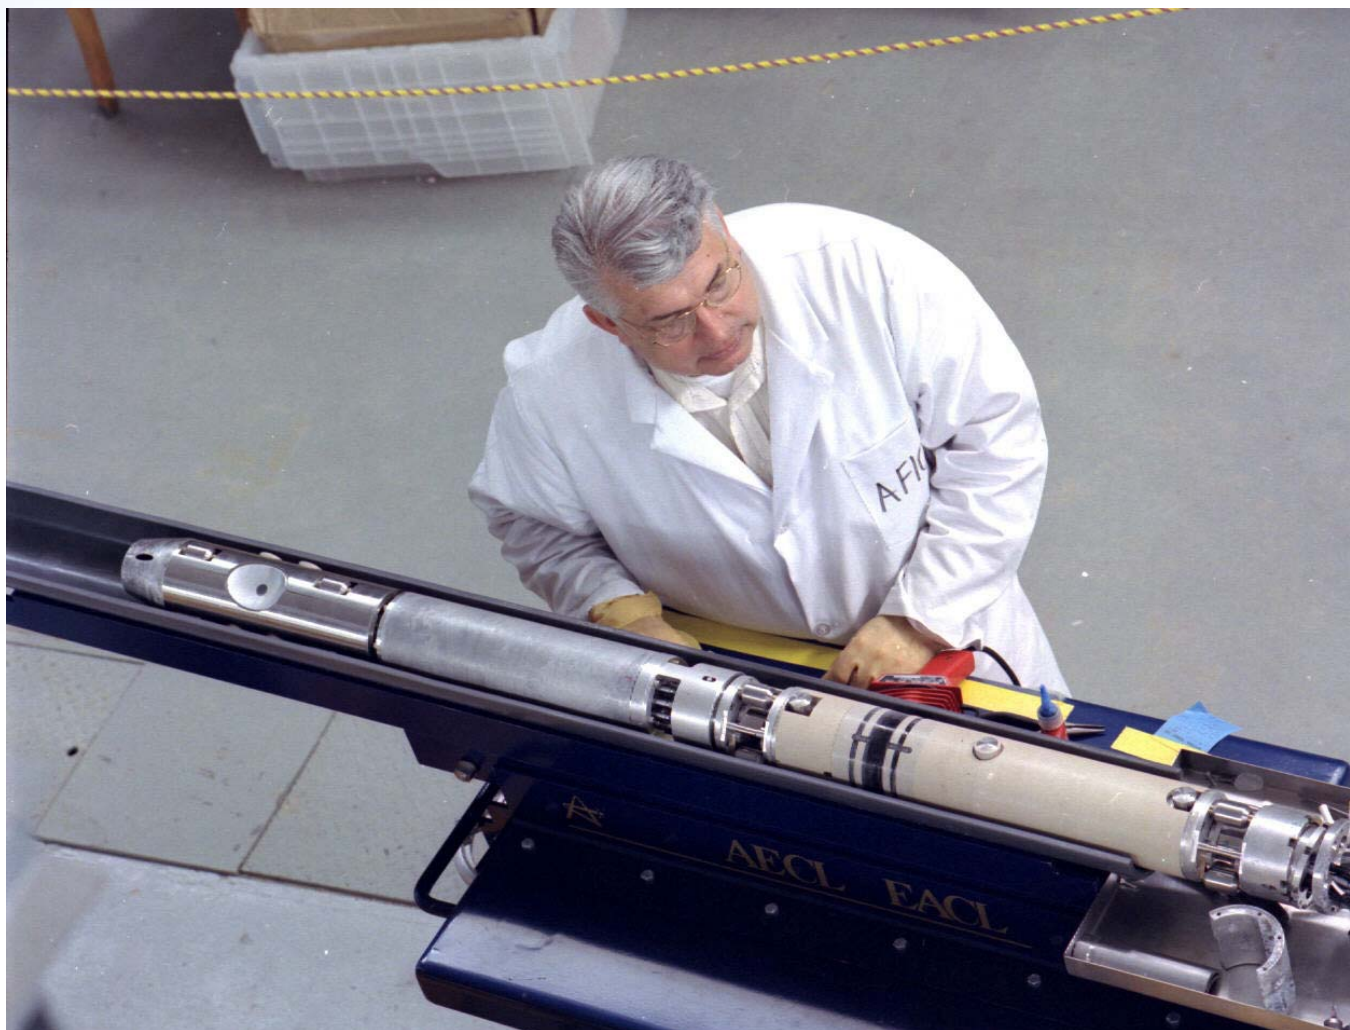
INSPECTION TOOLING

- Non-destructive
- Volumetric inspections required by CSA Standard
- Flaw detection
- Spacer locations
- Dimensional inspection – diameter and sag

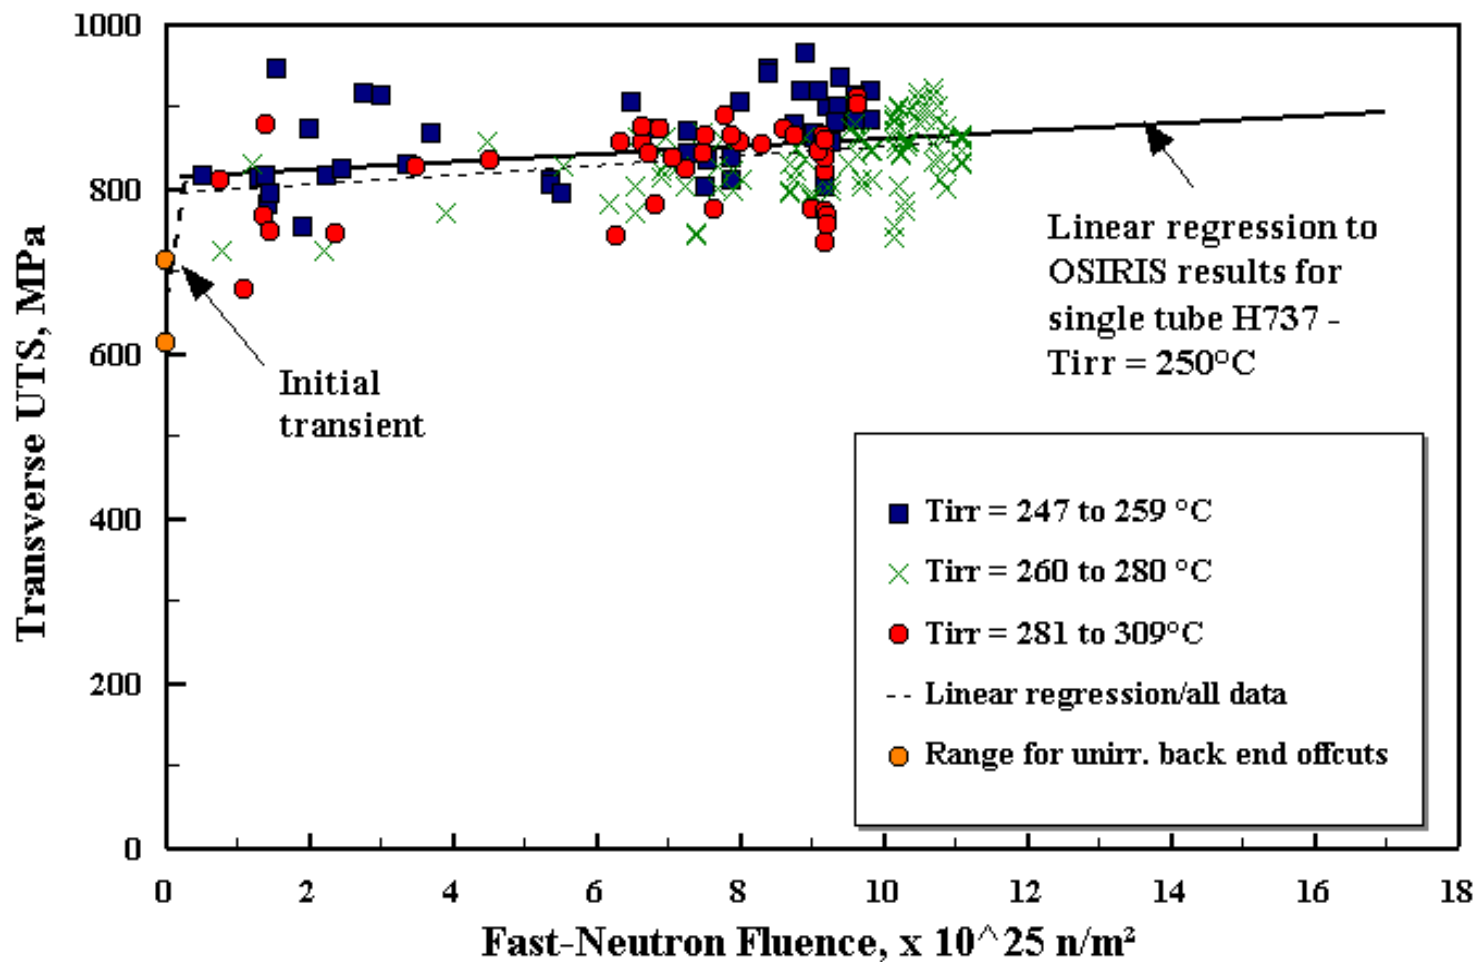
MATERIAL PROPERTIES

- Operating temperature
- Flux/Fluence
- Hydrogen Ingress
- Time

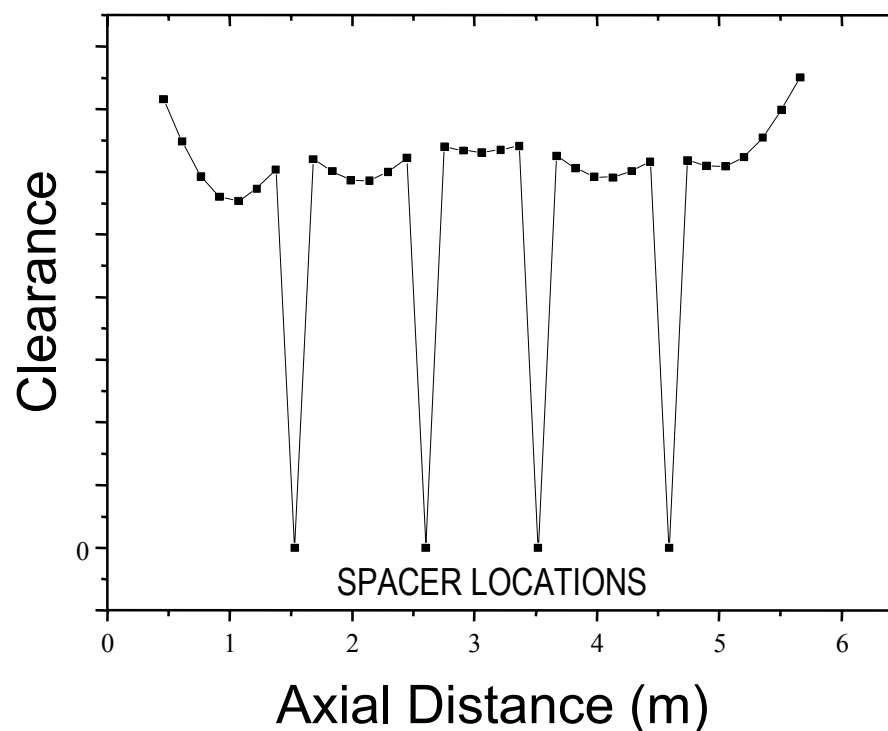
ACR R&D - DEFORMATION

- **Material Property data:**
 - Creep and growth
 - Microstructure
- **Extension of databases:**
 - Temperature
 - Irradiation
 - ACR specification

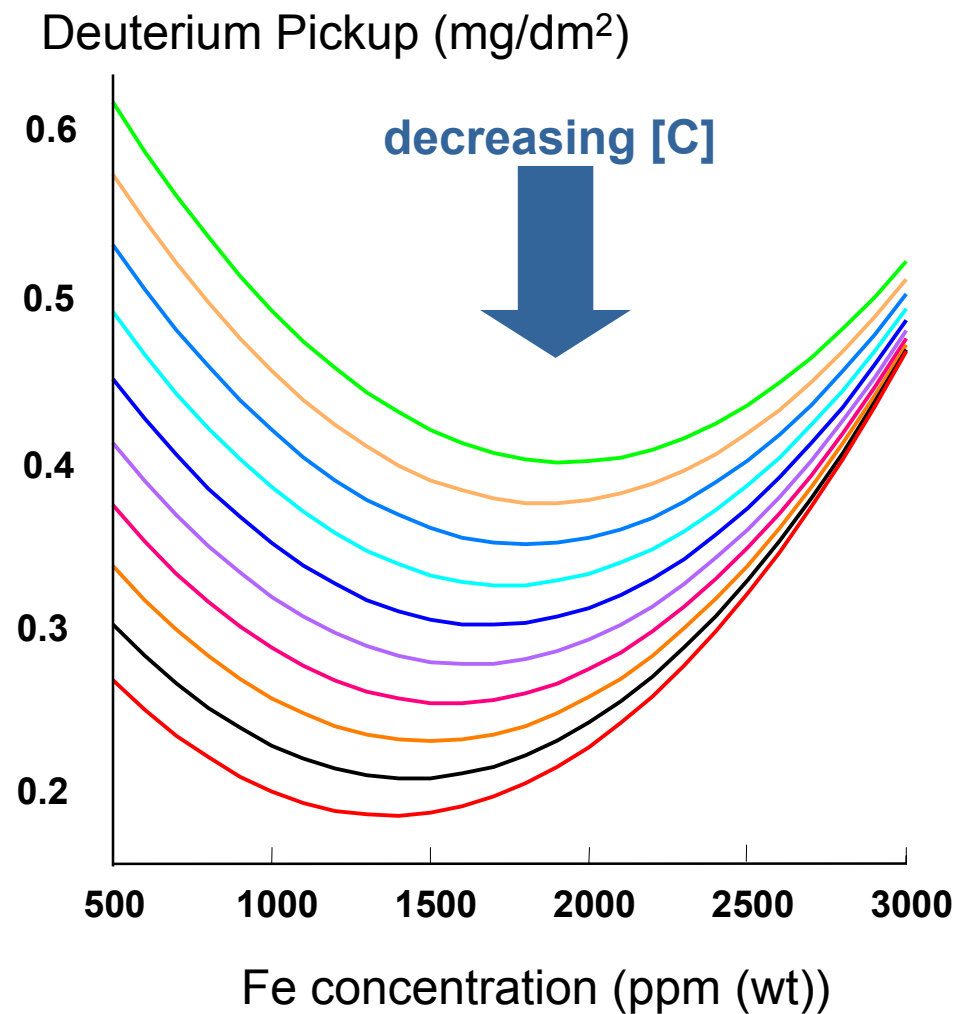
ACR R&D - CORROSION

- **Material Property data:**
 - Oxidation
 - Hydrogen pick-up
 - Hydrogen vs. Deuterium
- **Extension of Databases:**
 - Temperature
 - Irradiation
 - Microstructure
 - ACR specification

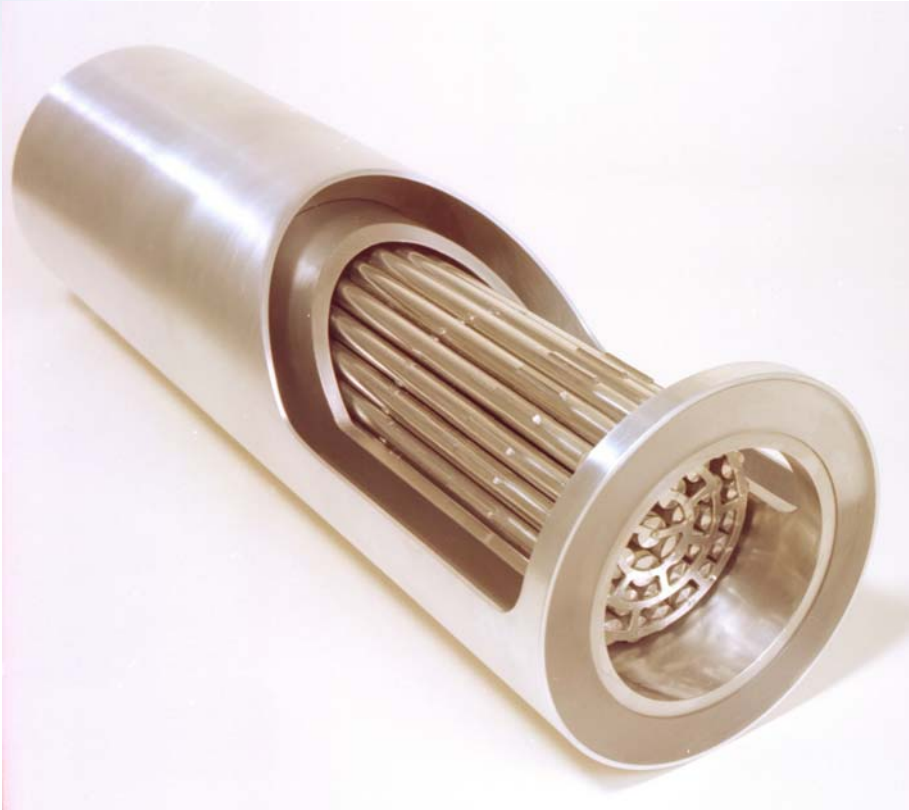
ACR R&D – CALANDRIA TUBES

- **Manufacturing of thicker calandria tubes**
- **Mechanical properties of ACR calandria tubes**
- **Postulated accident performance properties**
